# DURABILITY OF CARPENTER'S JOINTS IN HISTORIC TIMBERWORK ON THE EXAMPLE OF ROOF STRUCTURES FROM THE PERIOD OF 13TH-15TH CENTURIES

Marek R. Gogolin

Kazimierz Wielki University in Bydgoszcz

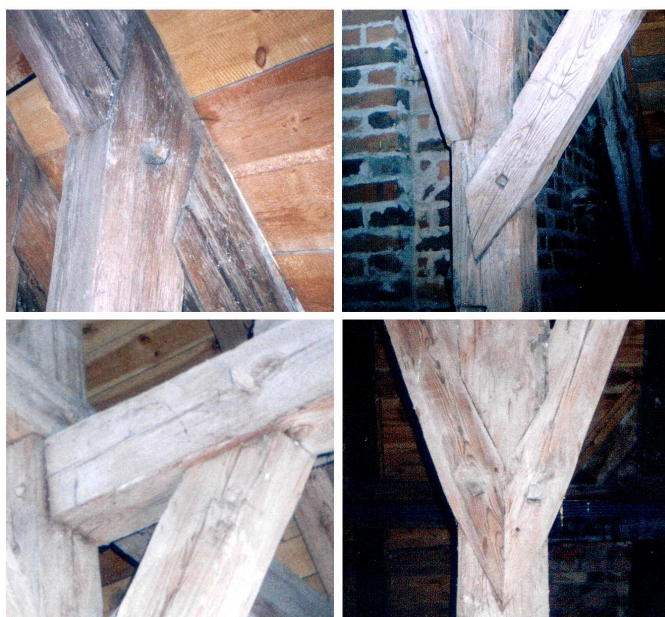
Fig. 2. Roof structure of the church in Lisewo/Liessau

The oldest of the discussed rafter framings, over the church in Lisewo/Liessau, was built in 1282 and is presumably the oldest roof timberwork preserved in Poland. In the nave section there are double king post rafter couples, while in the choir section single king post ones (Fig. 2). The joints used in those rafter couples are lap dovetail joints. They can be encountered where the collar-beams meet the rafters, where the ashlar pieces meet the rafters and tie beams and also where the struts meet the king posts and rafters. In stiffening lengthwise frames the mortise-and-tenon joints have been used where a longitudinal timber<sup>6</sup> meets the kings posts and lap dovetail joints have been used in braces stiffening the mortise-and-tenon joints. The material of all the construction elements has been preserved in a very good condition. The wood does not bear any evidence of destruction caused by biological factors (no traces of either feeding of insects' maggots or fungal growth). On the majority of construction elements one can see splits caused by drying of wood. Those splits run close to the axis of the elements and their depth does not exceed 4 cm, that is on the average ca. 15% of the given measure of the

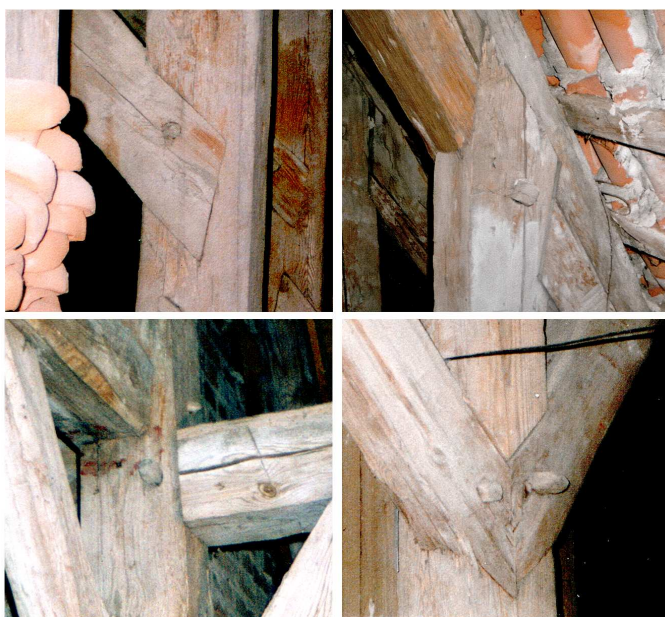
Fig. 3. Construction joints of the roof structure of the church in Lisewo/Liessau

cross-section. The lap dovetail joint connecting braces and struts with the collaborating elements does not have any traces of damage. Despite the lapse of time the fitting of the joints' elements has been preserved – the width of slits between the elements is not bigger than 1.5-2 mm (Fig. 3). The dowels securing the joints are fitted very tightly, one does not notice their loosening in any case, in spite of the fact, that in some cases lengthwise splits of the elements run through the dowel's hole. In king post frames tenon joints are also in a perfect condition. There is no sign of damage to the dowels or loosening of the joints, evidenced by tight fitting and practically no slits between the meeting surfaces of the elements. Measurements of the whole structure allowed for stating that it did not undergo any observable deformations. Particularly, no permanent deflection of the rafters<sup>7</sup> due to the long exposure to the load of heavy ceramic roof tiles has been encountered. One can thus ascertain, that all the timberwork and its elements have been preserved in a perfect condition in spite of over seven hundred years of their history.

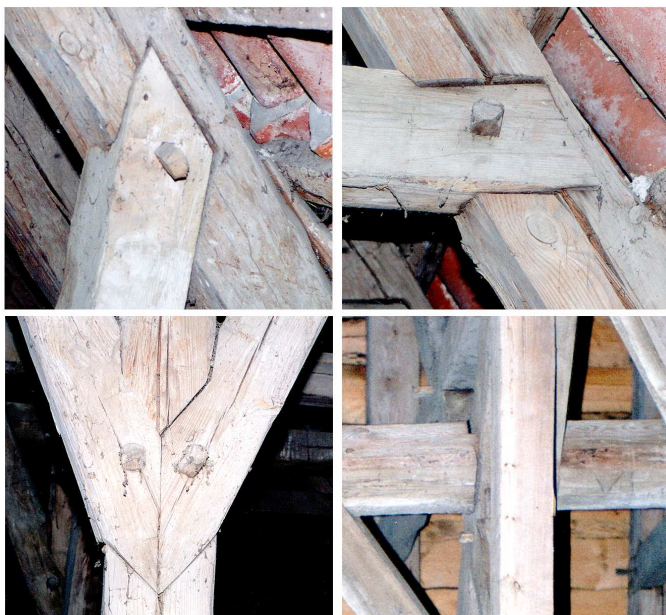
Fig. 4. Roof structure of the church in Grzywna/Griffen

The next construction is the roof structure over the church in Grzywna/Griffen, dating back to early 14th century. It consists of single king post rafter couples both in the nave and in the choir section (Fig. 4). Similarly to the previous structure lap dovetail joints and mortise-and-tenon joints have been used. The wood of particular elements of the frames has been preserved in a good condition and bears no traces of the influence of biological destructive factors. There are lengthwise splits running close to the axis of longer elements (rafters, king posts, struts and collar-beams) and on some of the braces. They are not deeper than 5 cm (3.5-4.5 cm on the average). Construction joints are preserved in a very good condition. In lap joints between the braces, rafters and tie beams as well as between the struts, rafters and king posts one can see a perfect fitting of the laps and mortises. The observable slits are not wider than 1 mm, in many joints there are no slits at all (Fig. 5). The fitting of securing dowels in their holes is tight, one does not also notice any traces of crushing of wood on the collaborating surfaces of the joint elements. The mortise-and-tenon joints in the king post frame do not bear any traces of destruction, their fitting is to be recognized as good (the slits not wider than 2 mm). Also the lap joints in that part of timberwork are preserved in a very good condition. The measurements did not reveal any distortions of the whole structure, also no permanent distortions of rafters have been encountered (deflection less than 2 cm). The full planking has been conducive to the good condition of the roof structure. It has additionally protected the timberwork against the leaking rainwater.

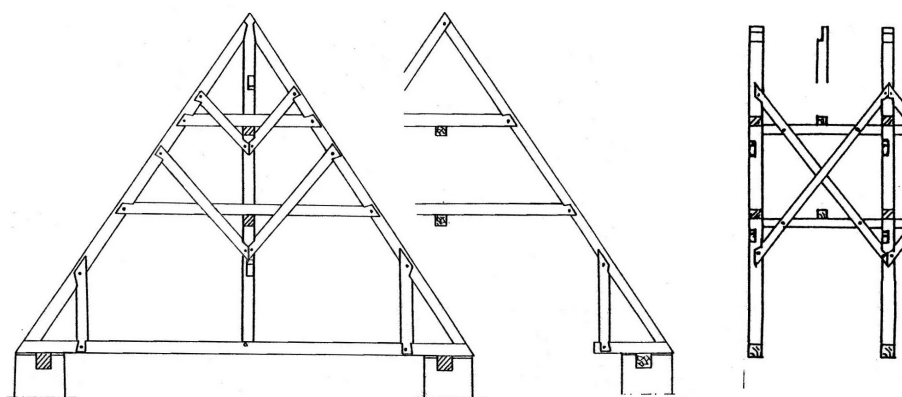
Fig. 6. Roof structure of the church in Subkowy/Subkau

The roof over the church in Subkowy/Subkau by Tczew/Dirschau was erected in 14th century. It is a single king post structure, built in two phases. The choir part dates back probably to the first quarter of 14th century, while the nave part is younger, of the late 14th or even early 15th century (Fig. 6). The construction joints of the rafter framing are the already described lap joints and mortise-and-tenon joints. The condition of wood in most of the elements is faultless. Only at the ends of some few tie beams and at lower ends of ashlar pieces one can notice traces of the presence of pests (feeding of the common Cerambycid *Hylotrupes baiulus* L. maggots). On a large number of elements one can see lengthwise splits

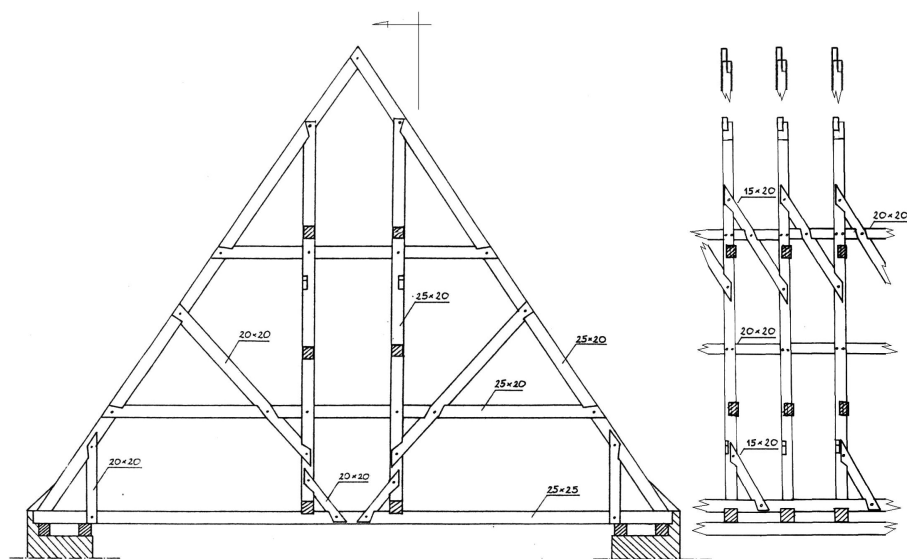
Fig. 7. Construction joints of the roof structure of the church in Subkowy/Subkau

up to 6 cm deep. Construction joints were executed with the same precision as in roof structures described above. In lap joints (both in the rafter couple plane and in lengthwise frame) between the tailpieces of the parts and the edges of mortises there are slits up to 7 mm. Side surfaces are fitted better and there the slits are not wider than 2-3.5 mm. Mortise-and-tenon joints in the king post frame were made correctly, however also not very precisely. One can notice slits up to 9 mm between the king posts' surfaces and the supporting surfaces of longitudinal timbers. This may mean that the tailpieces of the neighbouring tenons ram into each other in the mortise or that the axial forces in the joint are shifted by the dowel (Fig. 7).

However, despite the discovered shortcomings of the workmanship, the condition of joints is good. No distinct crushing of the wood on the collaborating surfaces of the elements has been noticed, there is also no other evidence of destruction. All the dowels are fitted very tightly, none of them is either cut or deformed. Also no deformation of the whole roof structure has been noticed, that confirms its good technical condition.

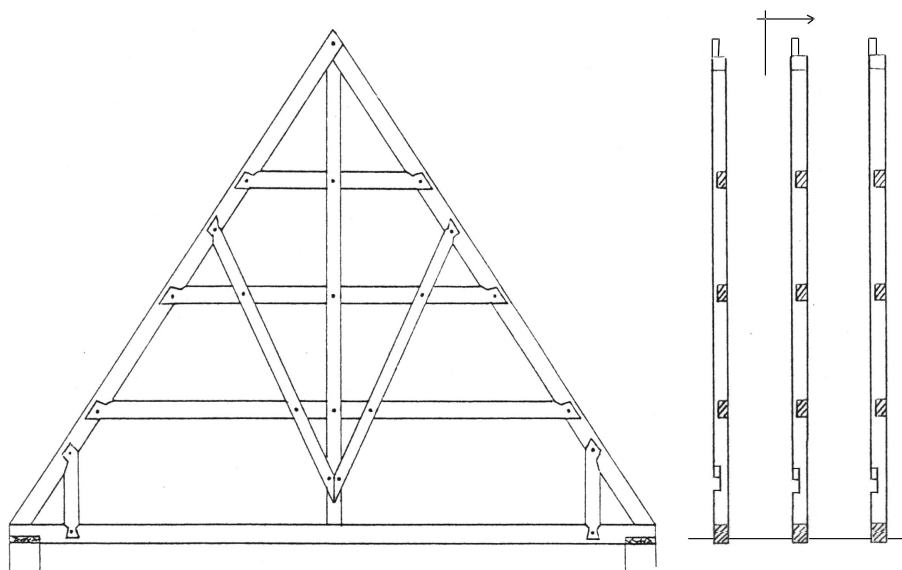
Fig. 8. Roof structure of the church in Lubiszewo/Liebschau

The rafter framing over the church in Lubiszewo/Liebschau dates back to mid-14th century (presumably ca. 1350) and belongs to king post roof structures (Fig. 8). The lap joints and mortise-and-tenon joints are applied in a manner

typical for the medieval carpentry. The construction material in most of the elements has been preserved in a good condition. There are lengthwise splits up to 5 cm deep visible, there is no evidence of pest infestation. Only few elements are definitely in much poorer condition. Lengthwise splits are deeper there, reaching up to 8cm, one can also see some alterations of colour being the evidence of fungal growth. The primary cause of that destructive phenomena was probably rainwater leaking through the untight roof covering, that was conducive to fungal growth and caused more extensive cracking of wood due to higromechanical effects connected with intense wetting and drying of the material. One of the elements (king post's strut has been replaced – probably due to the broken lap of the joint (the mortise does not bear traces of more advanced destruction). The condition of construction joints of the roof frame is generally good, however one can notice loosening of some joints caused either by drying of wood or by slapdash making. In the majority of lap joints the fitting of laps and mortises is quite satisfactory (slits up to 1 mm), however, in some of them the width of the slits run up to 10 mm. The mortise-and-tenon joints in the king post frame are in a good condition, with no

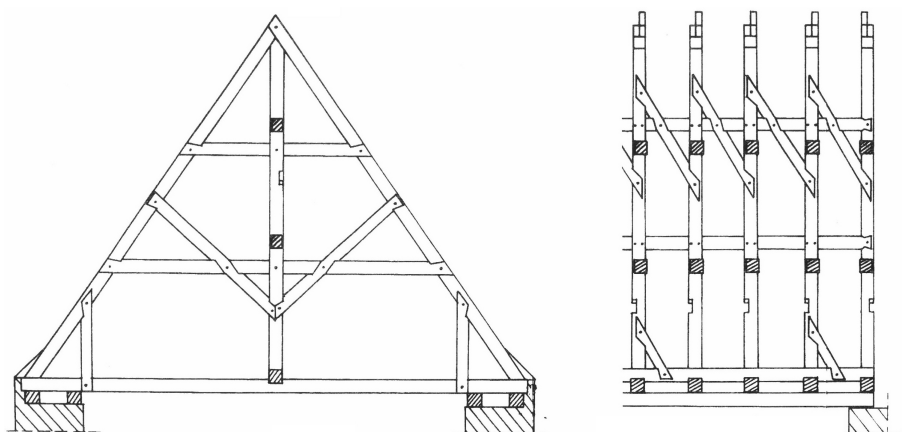
Fig. 9. Construction joints of the roof structure of the church in Lubiszewo/Liebschau

trace of unwanted slits between the collaborating surfaces of the elements (Fig. 9). Dowels in all the joints are fitted correctly, however, some of them have been replaced with new ones (this can be noticed in some of the joints bearing traces of fungal growths and damp). Measurements of the construction have not revealed any significant deformations, only the rafters bearing traces of leaking rainwater and fungal growth have deflection bigger than the others (ca. 5 cm on the average, while the other rafters have the deflection ca. 2 cm).
