# DURABILITY OF CARPENTER'S JOINTS IN HISTORIC TIMBERWORK ON THE EXAMPLE OF ROOF STRUCTURES FROM THE PERIOD OF 13TH-15TH CENTURIES

Marek R. Gogolin

Kazimierz Wielki University in Bydgoszcz

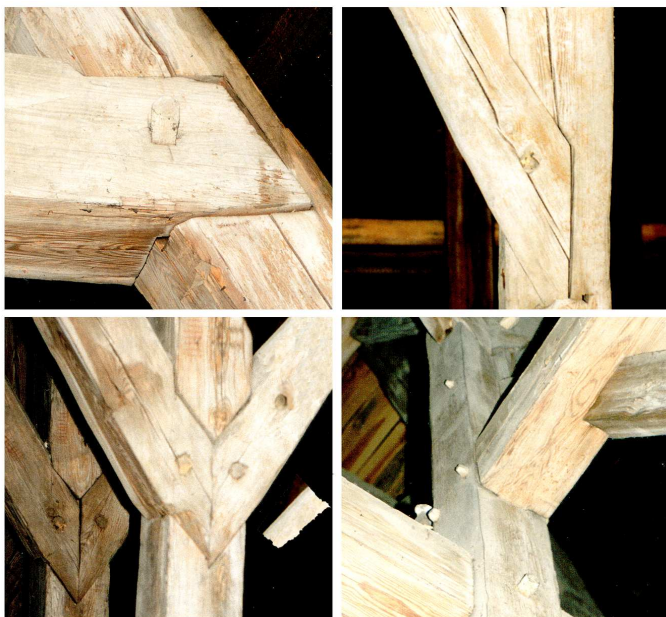
Fig. 5. Construction joints of the roof structure of the church in Grzywna/Griffen

The next construction is the roof structure over the church in Grzywna/Griffen, dating back to early 14th century. It consists of single king post rafter couples both in the nave and in the choir section (Fig. 4). Similarly to the previous structure lap dovetail joints and mortise-and-tenon joints have been used. The wood of particular elements of the frames has been preserved in a good condition and bears no traces of the influence of biological destructive factors. There are lengthwise splits running close to the axis of longer elements (rafters, king posts, struts and collar-beams) and on some of the braces. They are not deeper than 5 cm (3.5-4.5 cm on the average). Construction joints are preserved in a very good condition. In lap joints between the braces, rafters and tie beams as well as between the struts, rafters and king posts one can see a perfect fitting of the laps and mortises. The observable slits are not wider than 1 mm, in many joints there are no slits at all (Fig. 5). The fitting of securing dowels in their holes is tight, one does not also notice any traces of crushing of wood on the collaborating surfaces of the joint elements. The mortise-and-tenon joints in the king post frame do not bear any traces of destruction, their fitting is to be recognized as good (the slits not wider than 2 mm). Also the lap joints in that part of timberwork are preserved in a very good condition. The measurements did not reveal any distortions of the whole structure, also no permanent distortions of rafters have been encountered (deflection less than 2 cm). The full planking has been conducive to the good condition of the roof structure. It has additionally protected the timberwork against the leaking rainwater.
